# THE IMPACT RESISTANCE OF CURRENT DESIGN COMPOSITE FAN BLADES TESTED UNDER SHORT-HAUL OPERATING CONDITIONS

INTERIM REPORT

GENERAL ELECTRIC COMPANY  
Advanced Engineering and Technology  
Programs Department

NASA Lewis Research Center  
Contract NAS3-16777

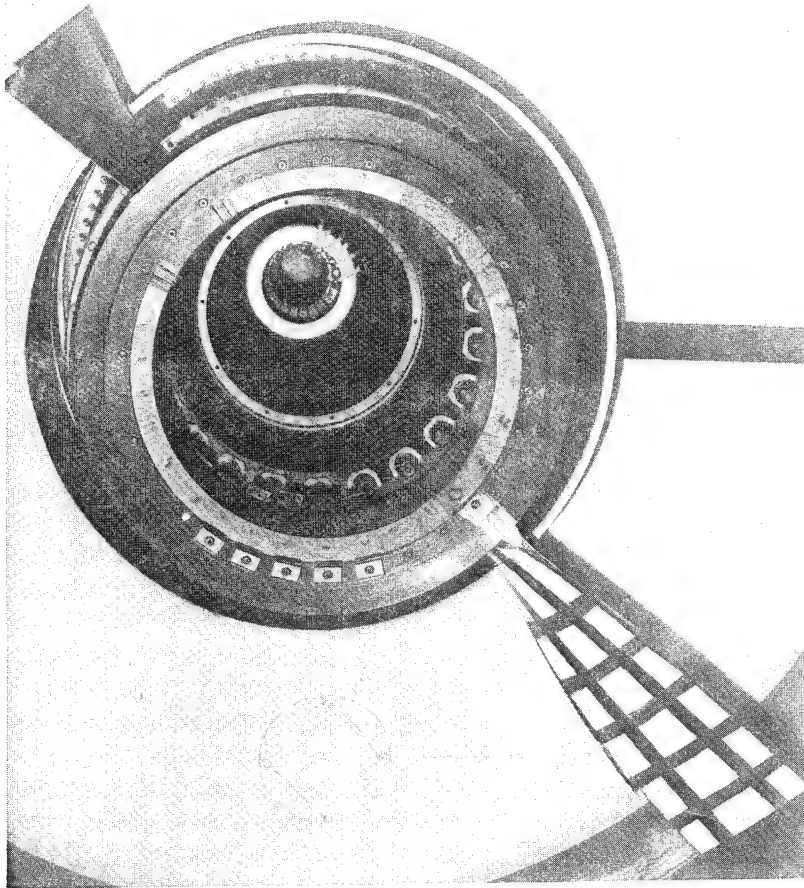
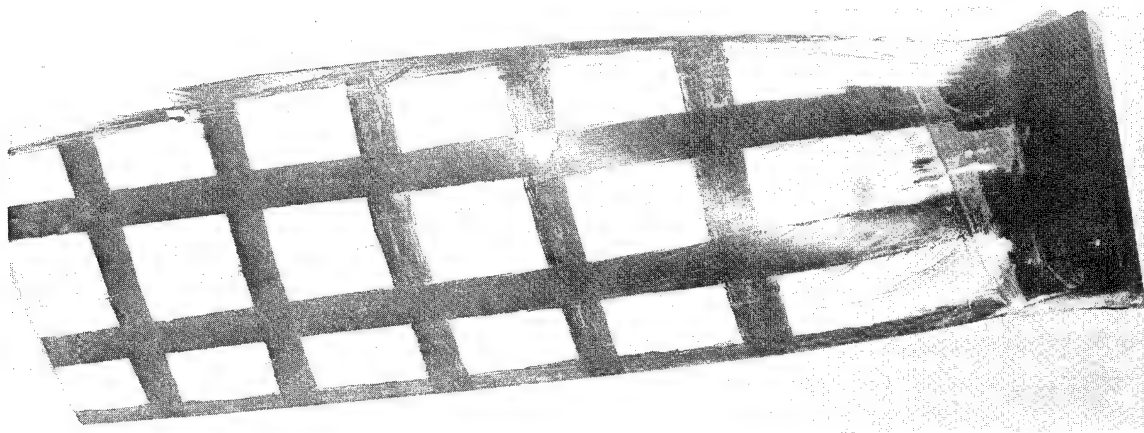
Figure 6. Blade S/N-NG1 after Impact.

For a 12 oz bird (simulated) with a 6 oz bite, both the graphite/epoxy and boron/epoxy blades were damaged yet remained intact. The graphite/epoxy experienced a crack in the dovetail and slight separation of the FOD protection from the leading edge on both sides of the airfoil. The boron/epoxy showed cracks at the tip at the leading and trailing edges with some delamination of the leading edge protection at the base of the airfoil.

Blade S/N	Bird Size	Bite Size	Damage*
NG1	12 Oz Simulated Bird	6 Oz	Loss of sliver and delamination at trailing edge of blade tip. Crack in dovetail.
NB2	12 Oz Simulated Bird	6 Oz	Radial crack in tip. Very small crack in dovetail at leading edge.
NG3	28 Oz Simulated Bird	12 Oz	Blade broke off at root.
NB4	28 Oz Simulated Bird	12 Oz	Blade broke off at root.
NG4	16 Oz Real Pigeon	11 Oz	Crack in root, as indicated by dye penetrant. Delamination in tip area.
NB3	16 Oz Real Pigeon	10 Oz	Delamination at base of leading edge, piece out of tip at leading edge. Delamination across tip.
Ti	16 Oz Real Pigeon	8 Oz	No damage.

NASA-FOD Impact Resistance Test  
 Blade S/N NG1  
 Graphite/Epoxy  
 Tip Speed: 800 ft/sec  
 12 oz RTV Bird  
 6 oz Slice  
 22° Incidence Angle

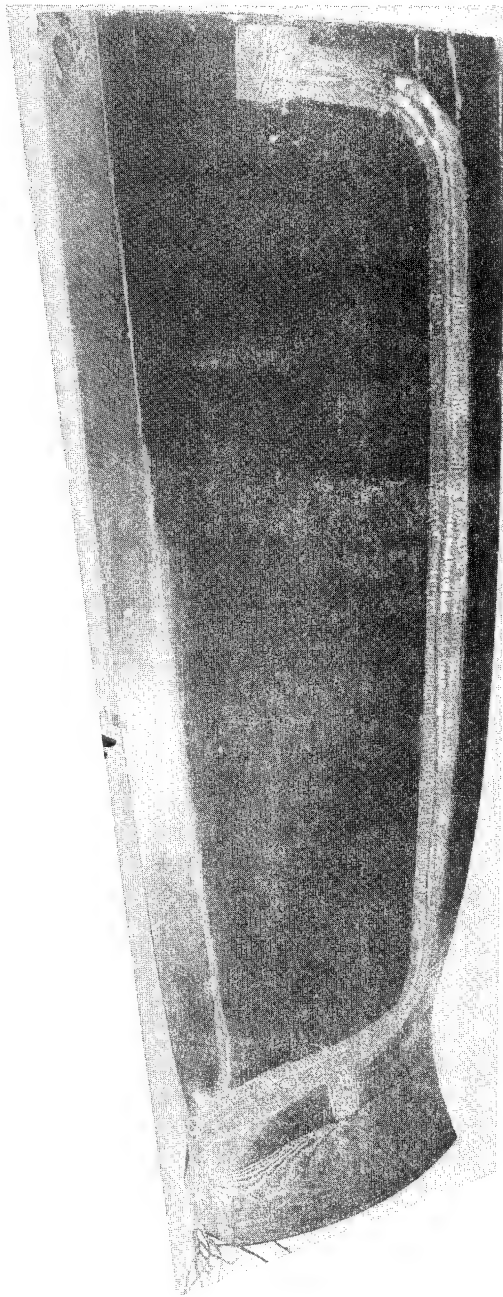
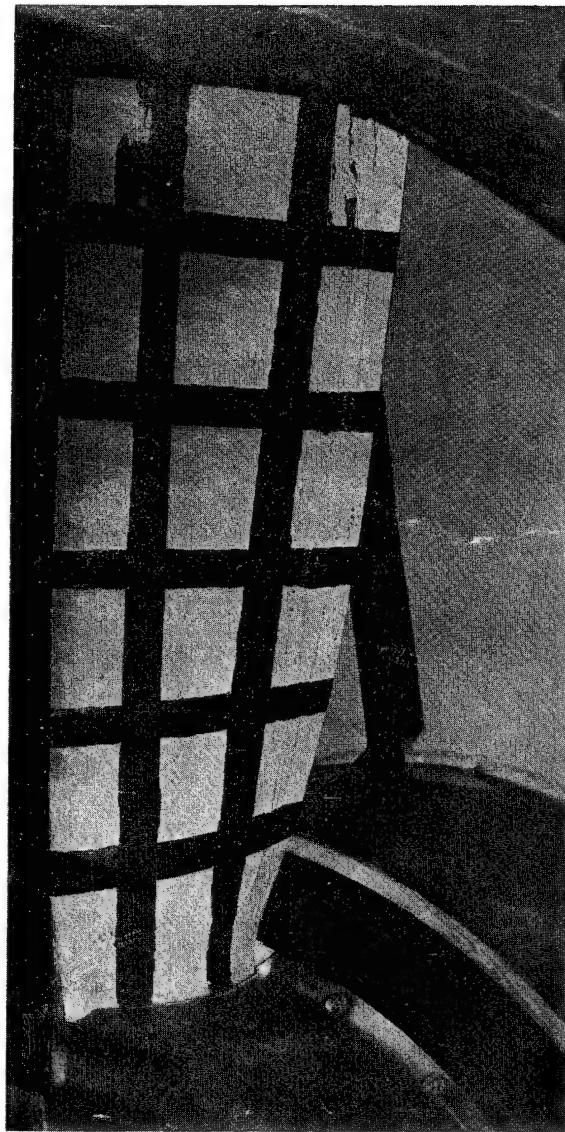
Figure 7. Blade S/N-NB2 after Impact.

NASA-FOD Impact Resistance Test  
Blade S/N NB2  
Boron/Epoxy  
Tip Speed: 800 ft/sec  
12 oz RTV Bird  
6 oz Slice  
22° Incidence Angle

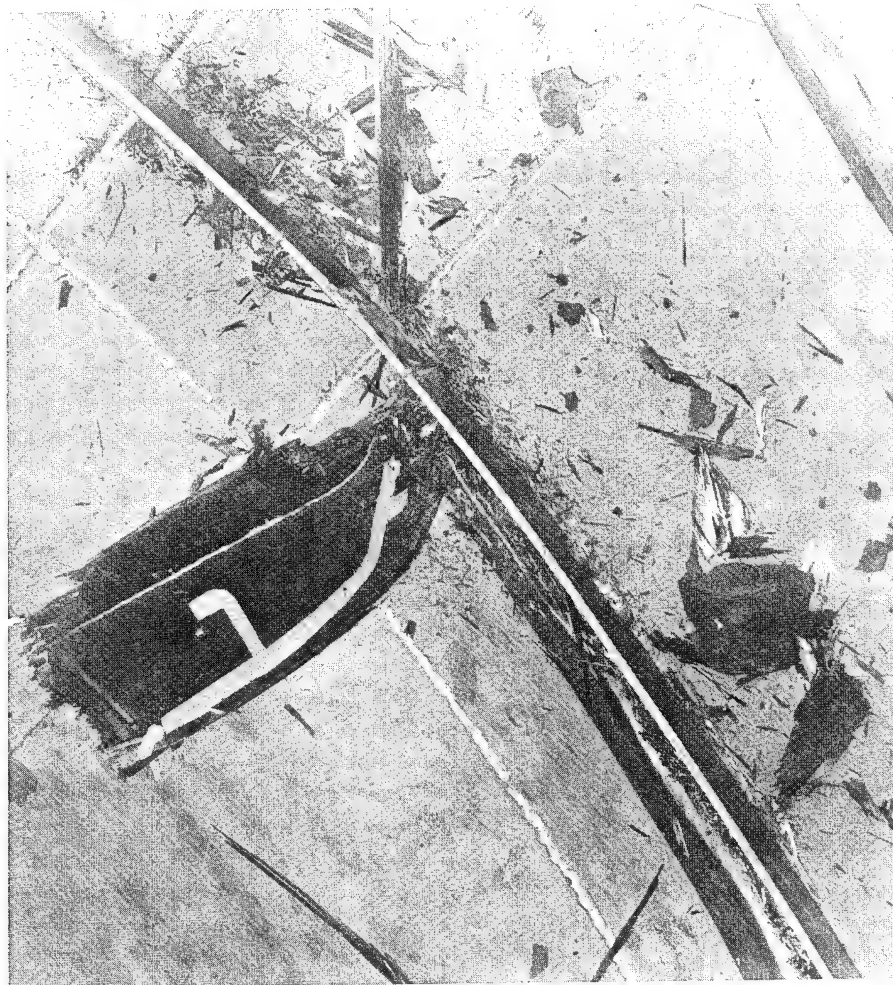
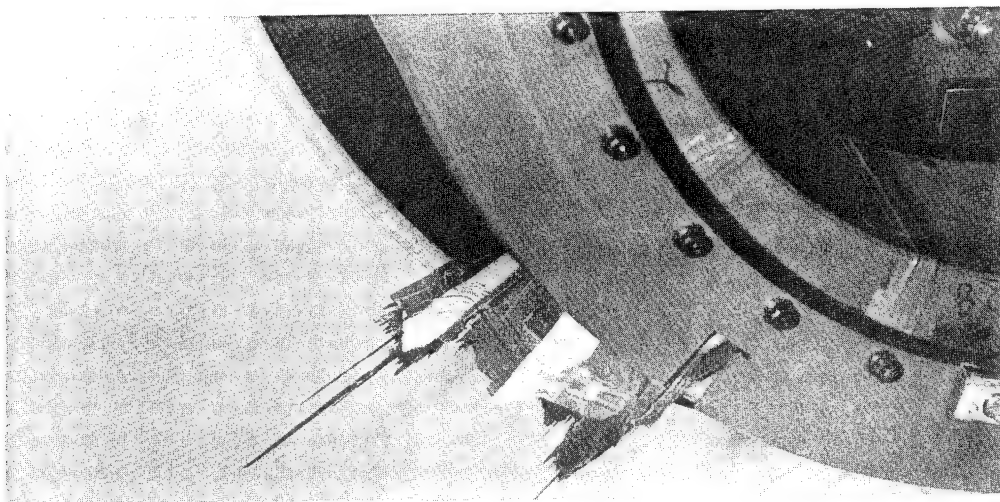
Figure 8. Blade S/N-NG3 after Impact.

A 12 oz bite off a 28 oz simulated bird caused blade failure, apparently resulting from high bending stresses, in both Gr/E and B/E blades at the airfoil root. The blades were contained easily and broke into relatively small pieces.

NASA-FOD Impact Resistance Test  
 Blade S/N NG3  
 Graphite/Epoxy  
 Tip Speed: 800 ft/sec  
 26 oz RTV Bird  
 12 oz Slice  
 22° Incidence Angle

Blade S/N NG3 12 Oz RTV	No NDT evaluation--too severely damaged.
Blade S/N NG2 Gravel, Ice Balls	No visible damage. TTUCS* indicated small debonded area along leading edge (LE) protection. Remaining airfoil undamaged. Dye penetrant inspection did not reveal any cracks or delaminations in the dovetail (D/T) after impact. Velocity measurements confirmed TTUCS data. No loss in velocity was noted as a result of impact.
Blade S/N NG4 11 Oz Pigeon	Visible damage - Splintered at the trailing edge (TE) tip; severe root damage. TTUCS shows large delamination area running from D/T to midway up the blade. Tip badly delaminated also. Dye penetrant inspection showed delamination crack running around entire D/T. Velocity measurements show reduced values over entire blade section after impact indicating internal damage.
Blade S/N NG1 6 Oz RTV	Visible damage - Piece missing from TE tip; crack in D/T slight separation of nickel from LE. TTUCS reveals delamination area at base plus damage at TE tip. Delamination in D/T can be seen in photos of dye penetrant check. Low velocity measurements were recorded at the base of the blade, trailing edge side, indicating internal damage. A decrease in velocity readings after impact was also observed in the tip region indicating some damage.

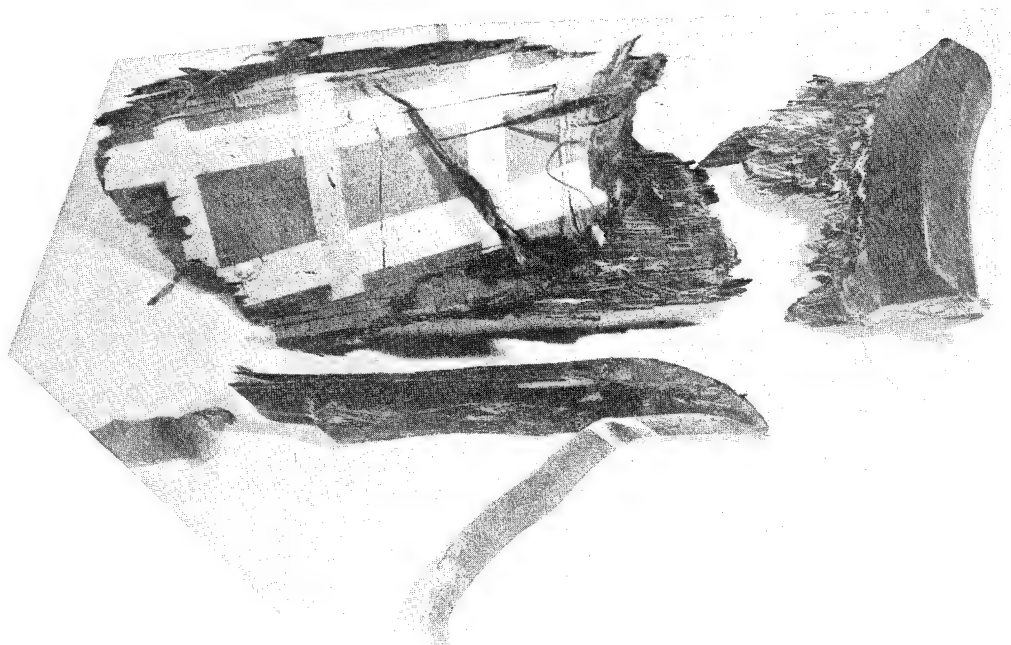
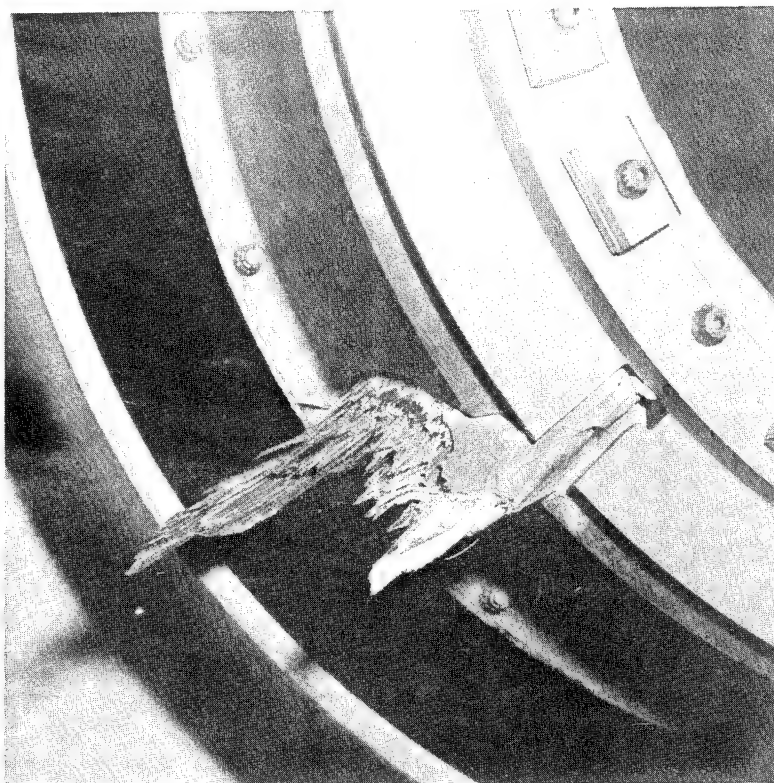
Figure 9. Blade S/N-NB4 after Impact.

NASA-FOD Impact Resistance Test  
Blade S/N NB4  
Boron/Epoxy  
Tip Speed: 800 ft/sec  
26 oz RTV Bird  
12 oz Slice  
22° Incidence Angle

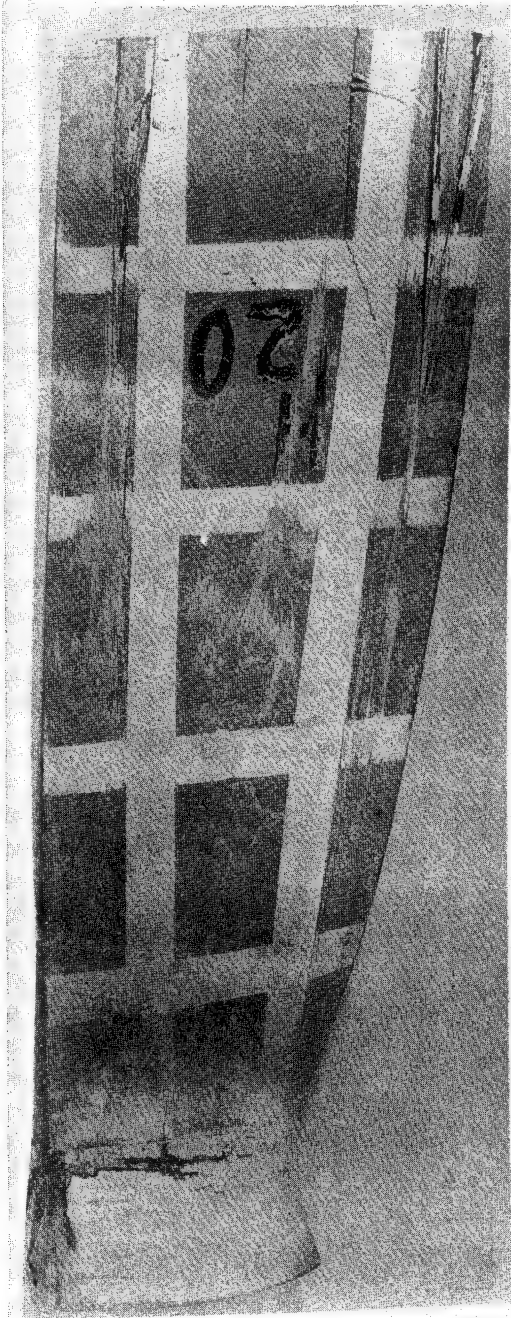
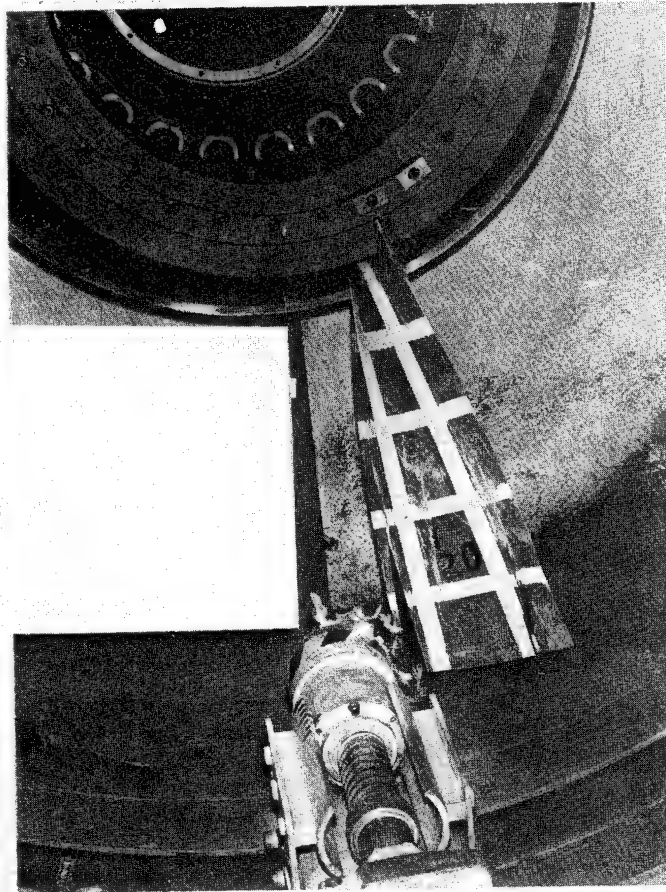
Figure 10. Blade S/N-NG4 after Impact.

For the 11 oz bite off of the 16 oz real pigeon, both blades were damaged as revealed by NDE results. The extent of damage resulting from this impact suggests the upper limit on the bird size which can impinge upon the composite blades under the test conditions described without failure at the root.

- Bench Frequency Check - The bench frequencies for the first three modes of all blades are shown in Table I. In addition, the after test frequencies for the first flex only are presented due to the extent of damage. These data show that for the most part, 1F frequencies remain the same. The biggest change in frequency occurred on graphite blade NG4 which was impacted with an 11 oz slice of a 16 oz pigeon.

NASA-FOD Impact Resistance Test  
Blade S/N NG4  
Graphite/Epoxy  
Tip Speed: 800 ft/sec  
16 oz Real Pigeon  
11 oz Slice  
22° Incidence Angle

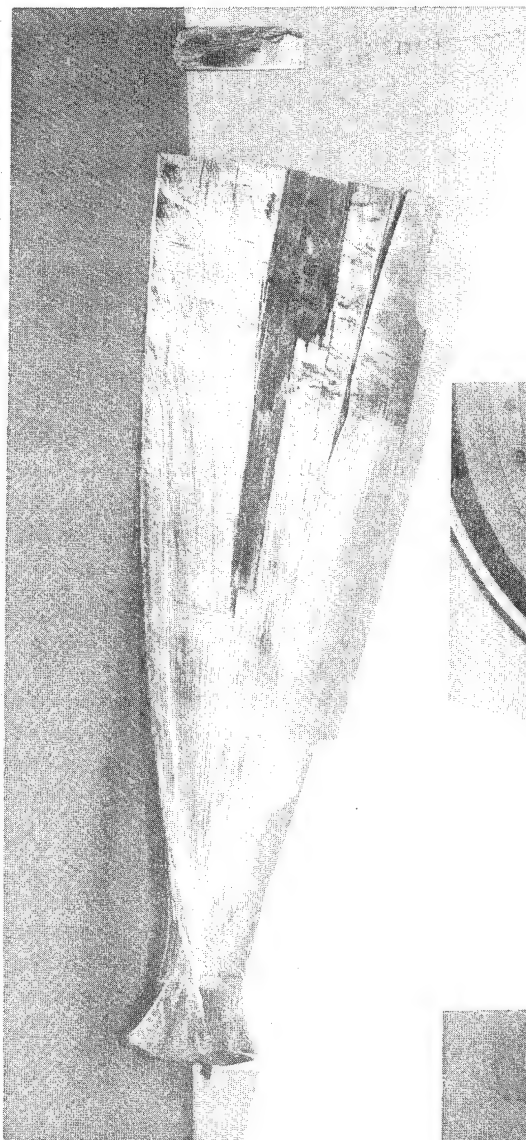
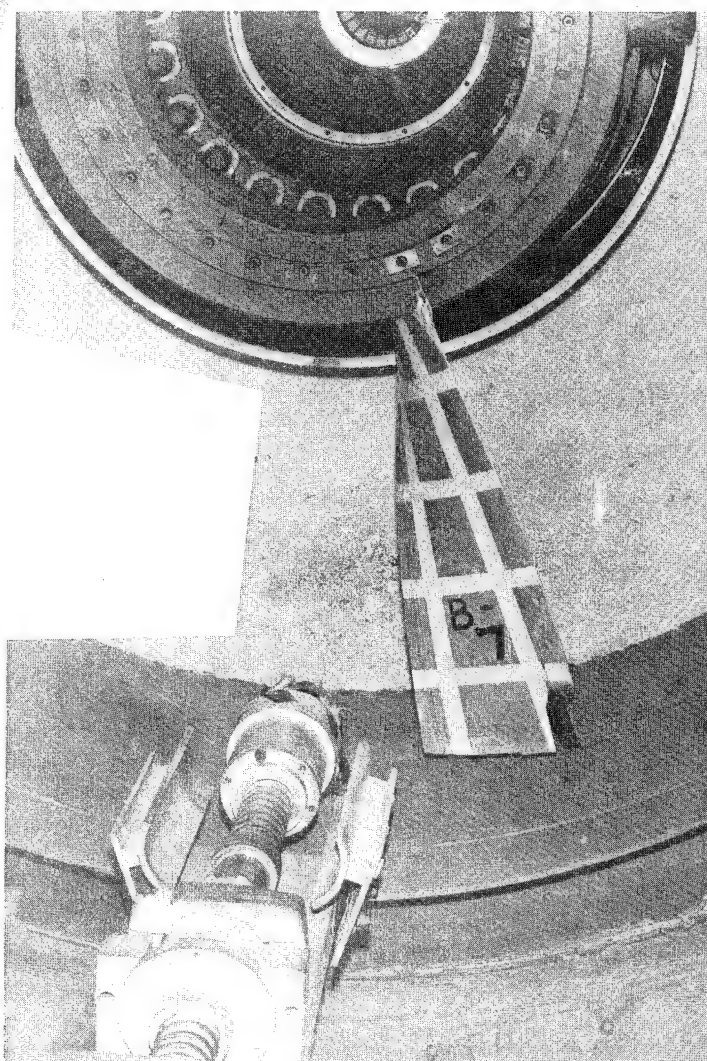
Figure 11. Blade S/N-NB3 after Impact.

NASA-FOD Impact Resistance Test  
Blade S/N NB3  
Boron/Epoxy  
Tip Speed: 800 ft/sec  
16 oz Real Pigeon  
10 oz Slice  
22° Incidence Angle

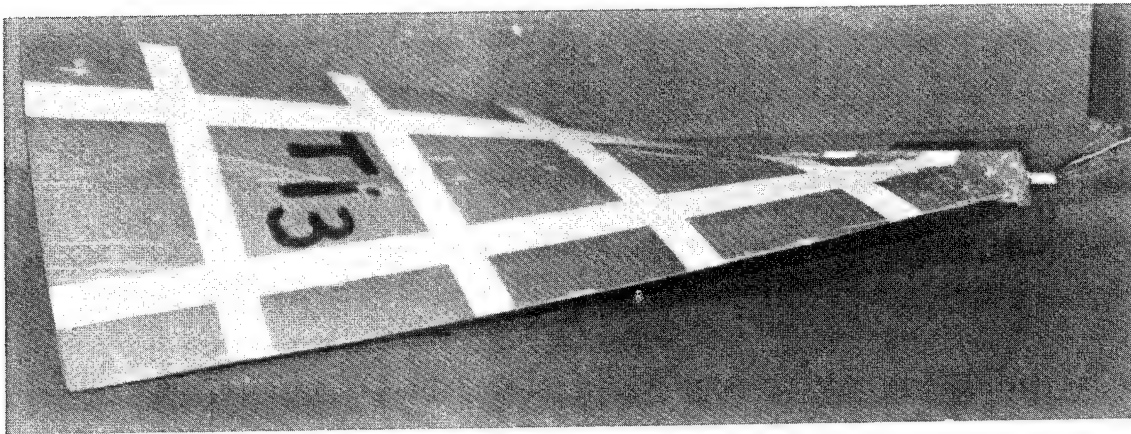
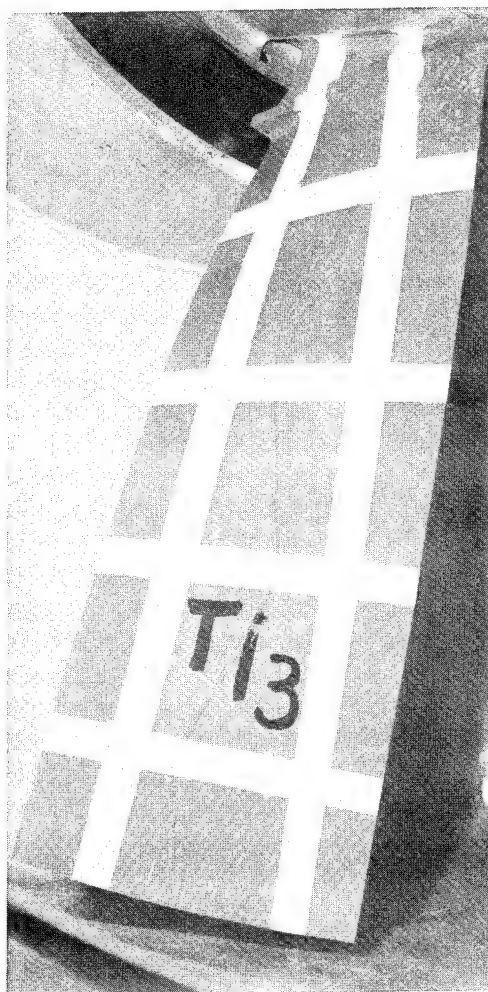
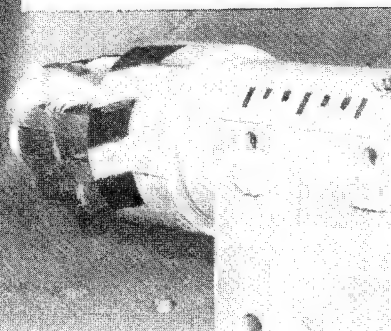
Figure 12. Titanium Blade after Impact.

There was no visible damage to the titanium blade when impacted with an 8 oz bite from a 16 oz pigeon. There was considerable deflection.

NASA-FOD Impact Resistance Test  
 Blade S/N Ti3  
 Titanium  
 Tip Speed: 800 ft/sec  
 16 oz Real Pigeon  
 8 oz Slice  
 22° Incidence Angle

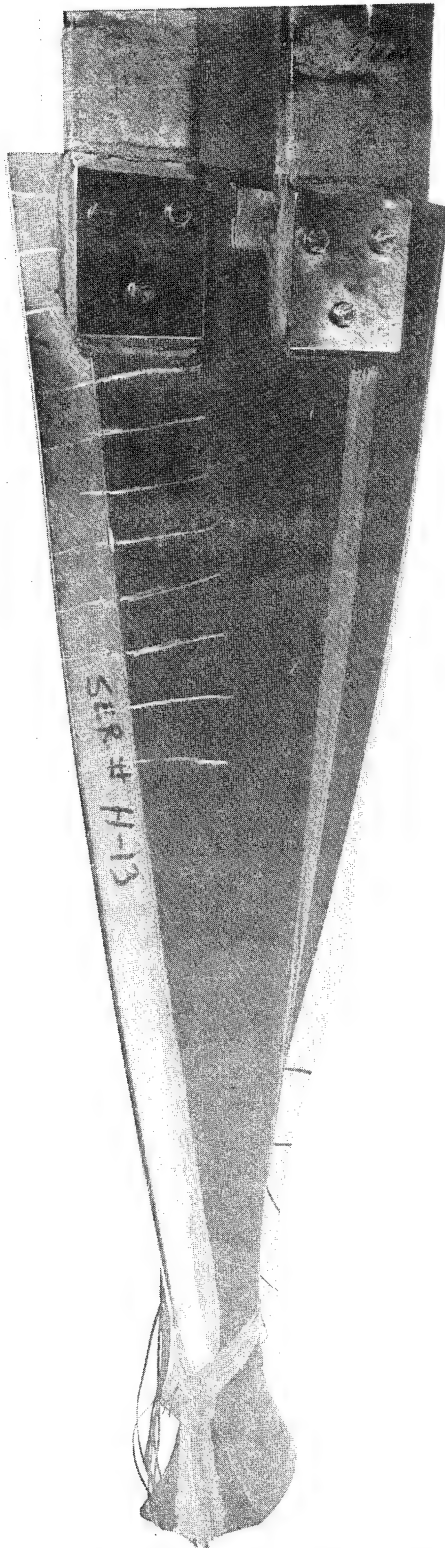
Figure 19. NG5 Graphite/Epoxy Blade  
after Impact (Convex Surface),  
Test No. STOL 1.

The specimen is shown in Figure 19 (convex view) and 20 (concave view). The only visible damage to the blade was a rather clean crack extending down from the tip section a distance of less than three inches. The chalk coating can still be seen adjacent to the projectile path (Figure 19) which extended across the entire blade chord. The convex surface of the blade was marked only with short line segments extending back from the leading edge. The lines can be seen clear to the leading edge, demonstrating thereby that no projectile interaction has taken place on the convex surface. The axial load measured after the test showed the same level as before the test.

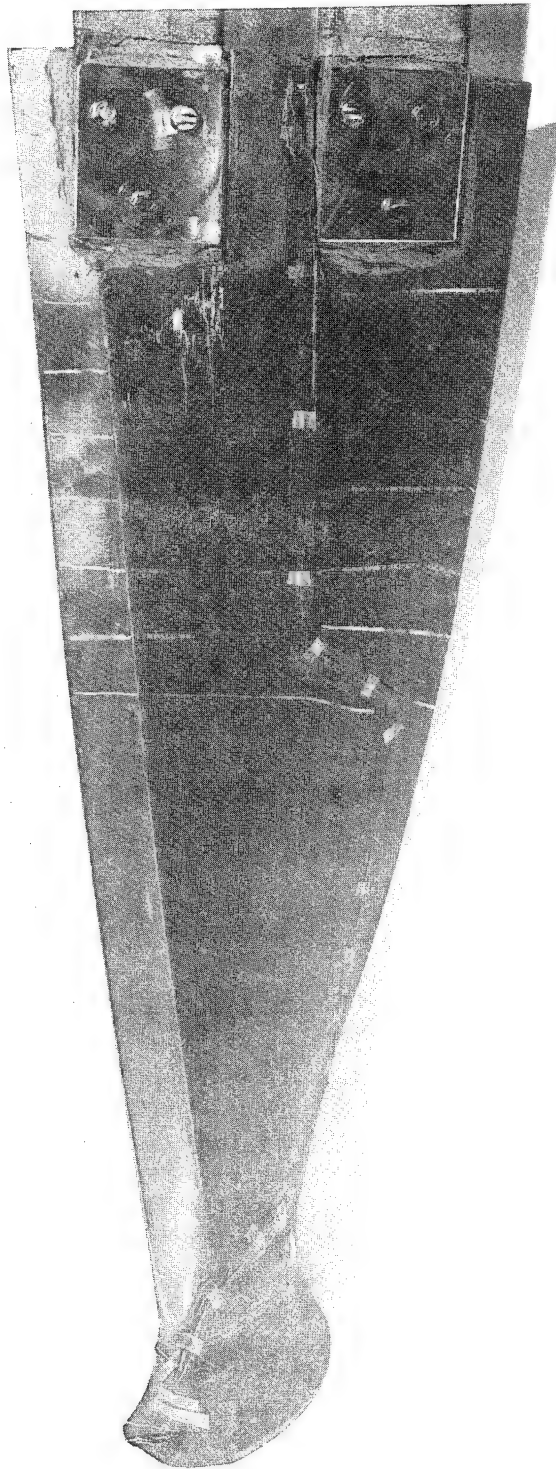
Figure 21. NB5 Boron/Epoxy Blade after  
Impact (Convex Surface), Test  
No. STOL 2.

The boron/epoxy blade is shown after impact in Figures 21 (convex) and 22 (concave). This blade was damaged much more severely than the graphite blade. The principal damage consisted of cracks and multiple delaminations extending down from the tip section and situated again between the loading straps. The damage is especially clear in Figure 22. Similar indications of projectile interaction can be seen here as well.

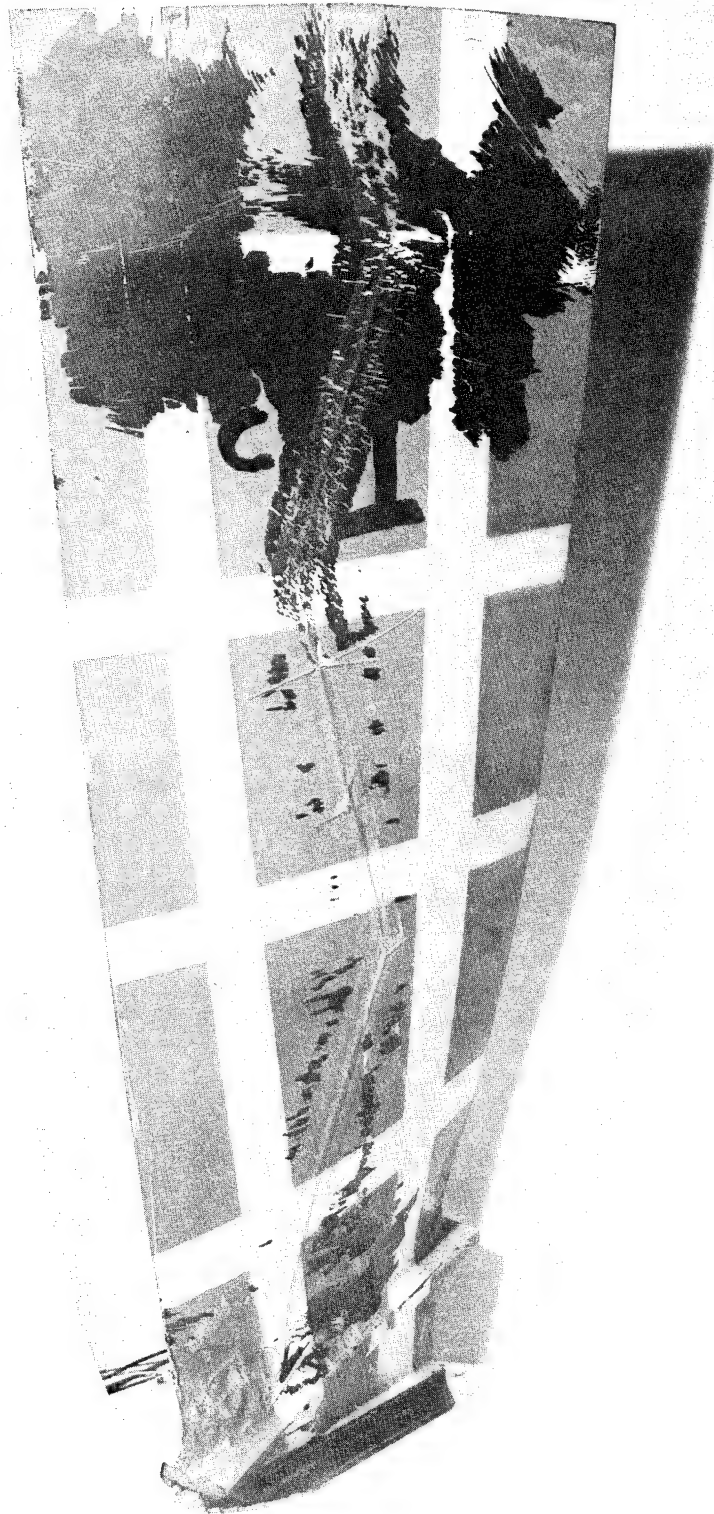
Figure 23. Titanium Blade after Impact  
(Convex Surface), Test No.  
STOL 3.

The titanium blade impacted in the third test is shown in Figures 23 (convex) and 24 (concave). The blade was not fractured but was perceptively deformed at the leading and trailing edges along the projectile path.
